**Steeple Renewables Project**

Appendix 7.9: Otter and water vole  
report

| <b>Project number</b> | P22-761 Appendix 7.9 Otter and water vole report |

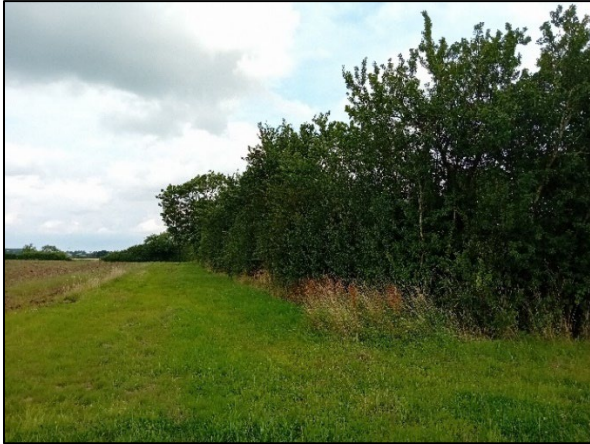
Photograph 7.9.1: View of AA1 from the southwest including adjoining hedgerow.

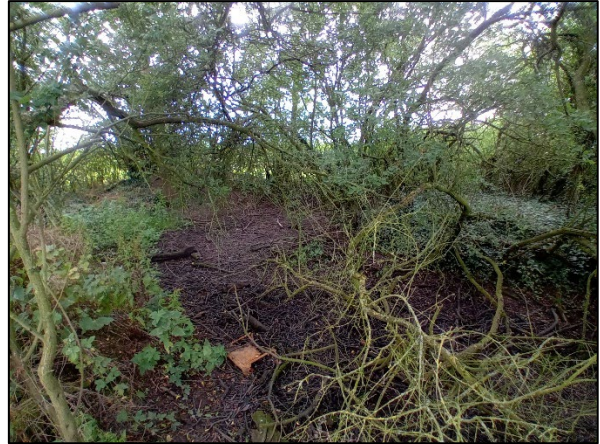
Photograph 7.9.2: Area of open structure and ephemeral pond within AA1.

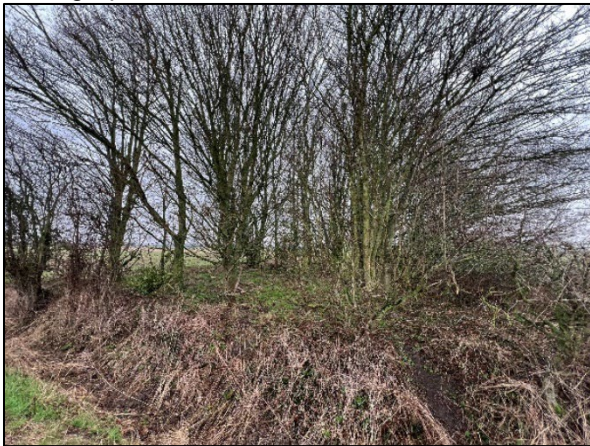
- 3.11 Three discrete parcels of land within the Site were identified during the desk study as having potential to support otter resting sites. With reference to Figures 7.9.1.1 and 7.9.1.2, Area AA1 supports two copses of plantation broadleaved woodland connected by a hedgerow. These two areas of plantation support dense understorey and scrub with an ephemeral pond in the north (Photographs 7.9.1 and 7.9.2). Area FA1 is a broadleaved woodland copse at the intersection of three on-Site ditches, FD5, FD6 and Z15 (dry ditch). During the extended habitat surveys in spring 2024, no evidence of otter or possible resting sites, such as holts or couches, were identified within areas AA1 or FA1. The survey also concluded FA1 is sub-optimal terrestrial habitat for otter due to limited understorey cover that could provide places of shelter (Photographs 7.9.3 and 7.9.4).

Photograph 7.9.3: View of FA1 from the northeast.

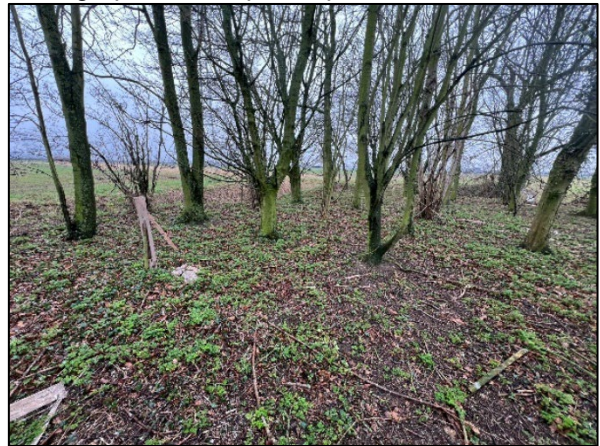
Photograph 7.9.4: Open/exposed nature of FA1.

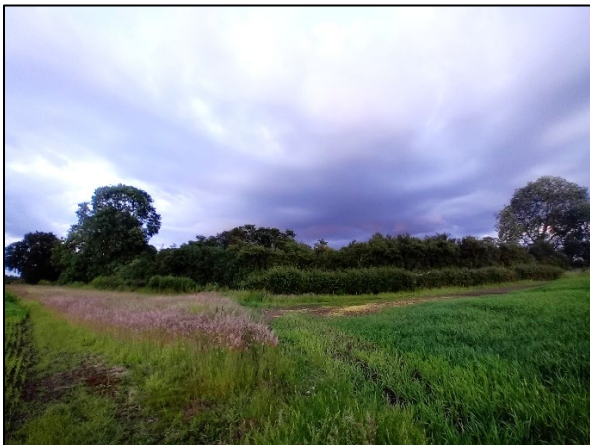
- 3.12 Area FA2 is a parcel of semi mature broadleaved woodland with ditches FD8 and FD9 bordering the northeast and east respectively (Photographs 7.9.5 and 7.9.6). A single hole under a tree root on the northern edge of FA2 and southern bank of ditch FD8 was identified during the extended habitat surveys; it was recorded as having dimensions that would make it suitable to function as an otter resting site, although at the time of the survey, high water levels had caused water to run out of the hole under the root and into the ditch. Further investigation during lower water levels on 04 September 2024 found the hole to be formed of a ca. 20 cm metal pipe; no signs of use by otter were recorded but it could not be discounted as a possible resting site in dry weather. It is, however, considered unlikely to support a natal site due to the fluctuation in water levels in and around the hole.

Photograph 7.9.5: L View of FA2 in the southwest.

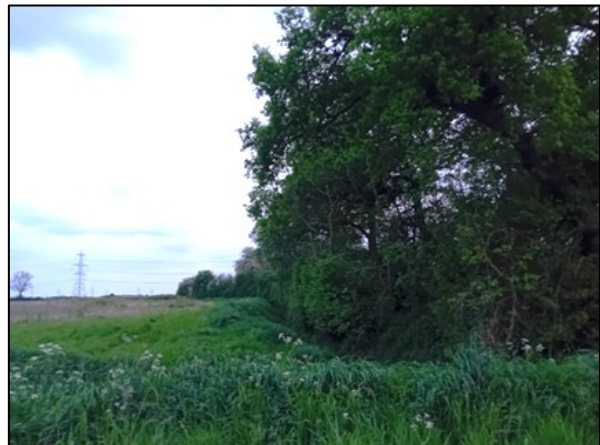
Photograph 7.9.6: FA2 at intersection of ditch FD8 and FD9 in the northeast.

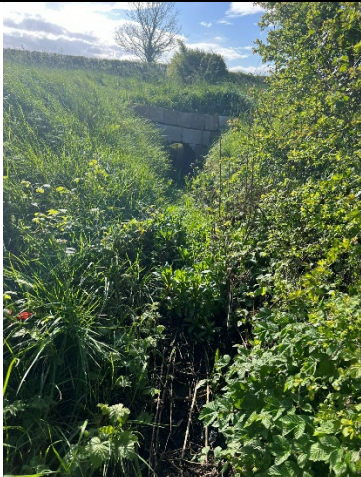
| <i>Feature</i> | <i>Water depth (cm)</i> | <i>Width (m)</i> | <i>Water flow</i> | <i>Bank profile (°) and material</i> | <i>Vegetation description and comments</i> | <i>Water vole suitability</i> | <i>Photograph (April 2024)</i> |
|---|---|---|---|---|---|---|--|
| AD3 | N/A | 0.7 | N/A | 45, soil | Trees, bushes, herbs present, grasses, submerged and emergent absent.<br><br>Example of dry ditch, choked with tall vegetation. | Negligible | |

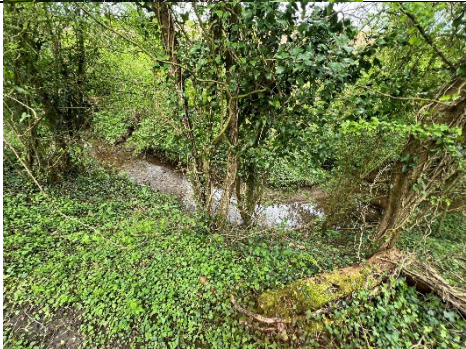
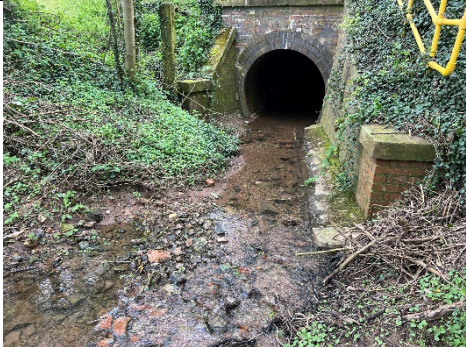
| <i>Feature</i> | <i>Water depth (cm)</i> | <i>Width (m)</i> | <i>Water flow</i> | <i>Bank profile (°) and material</i> | <i>Vegetation description and comments</i> | <i>Water vole suitability</i> | <i>Photograph (April 2024)</i> |
|---|---|---|---|---|---|---|--|
| CD1 | 20 | 1 | Rapid | 40, soil and bedrock | Trees, bushes, herbs and grasses present, submerged and emergent absent.<br><br>Heavily shaded, areas eroded to bedrock. | Good | |

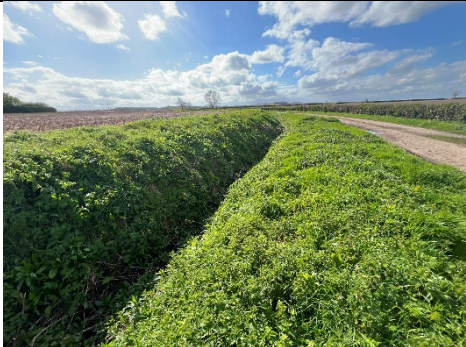
| DD4 | <3 | 0.5 | N/A | 50, soil | Trees rare, bushes, herbs and grasses present, submerged and emergent absent. Heavily shade west of culvert.<br><br>Dried by September 2024. | Negligible | |

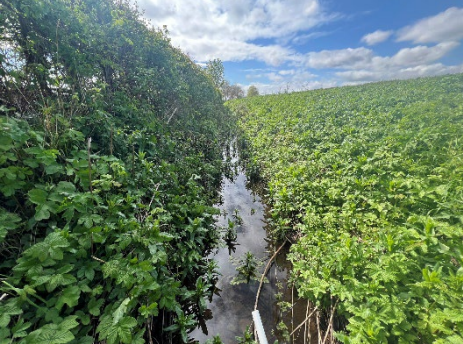
| DD6 | <3 | 0.5 | N/A | 50, soil and stone | <p>Trees rare, bushes, herbs and grasses present, submerged and emergent absent.</p> <p>Dominated by bramble in areas.</p> <p>Dried by September 2024.</p> | Negligible | |

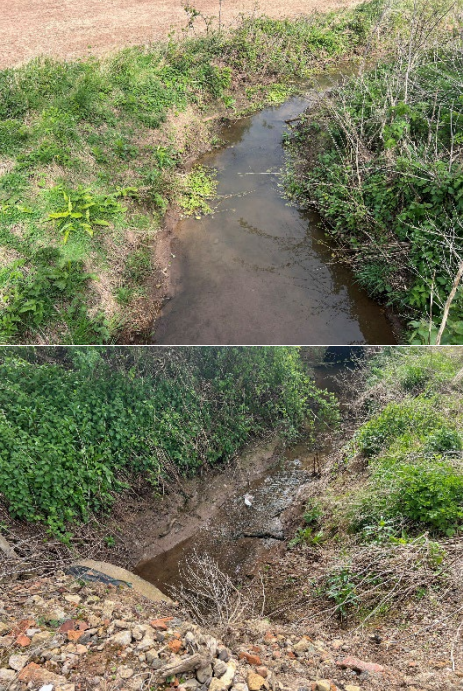
- 2.17 Ditch DD8 and the north to south section in the southeast of CD1(D) was not accessed during the September 2024 surveys because of the hazard of accessing the steep banks and poor visibility

| DD8 | 30 | 1 | Rapid | 90, soil and bedrock | <p>Trees, bushes, herbs and grasses present, submerged and emergent absent.</p> <p>Heavily shaded, areas eroded to bedrock.</p> | Poor | |

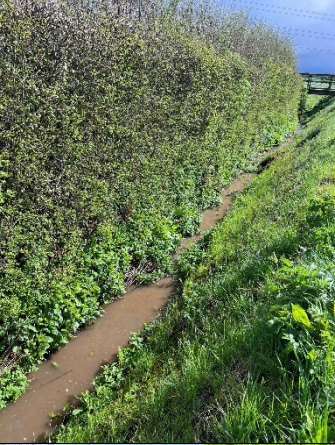
| ED1 | 0-6 | 1 | Slow | 60, soil and shale | <p>Trees absent, bushes, herbs, grasses and emergent present, submerged absent.</p> <p>Dried by September 2024.</p> | Negligible | |

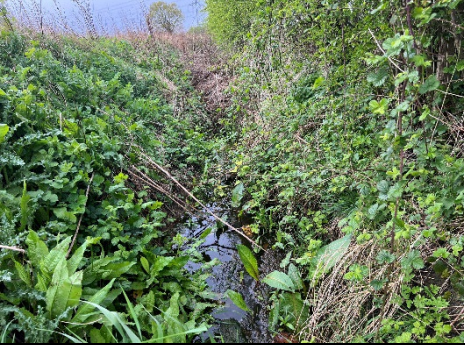
| ED2 | 0-10 | 0.5 | N/A | 50, soil | <p>Trees absent, bushes, herbs, grasses and emergent present, submerged absent.</p> <p>Dried by September 2024.</p> | Negligible | |

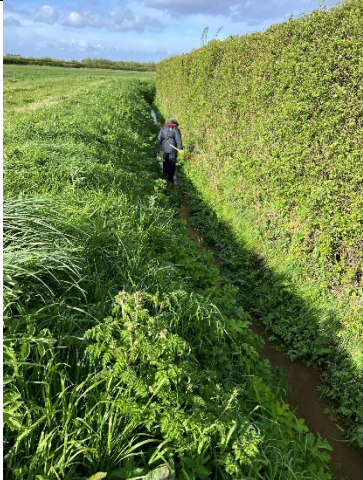
| ED4 | 15 | 0.9 | Slow | 60, soil | <p>Trees absent, bushes dominant, herbs, grasses, submerged and emergent present.</p> | Good | |

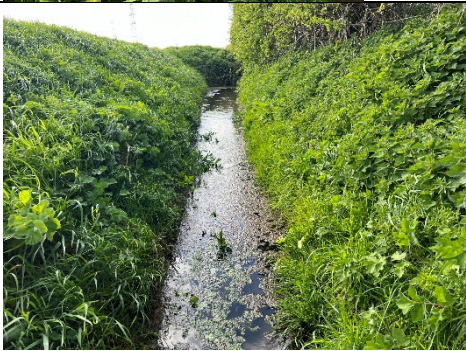
| ED5 | 15-25 | 0.7-1 | Slow | 70, soil and silt | <p>Trees, bushes, herbs, grasses, submerged, and emergent present.</p> <p>Shallow, if it were to dry out in the summer, it would be poor suitability for water vole.</p> | Good | |

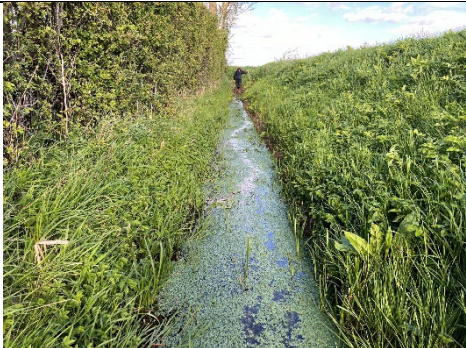
| ED6 | 15 | 0.7 | Slow | 45, soil | <p>Trees, bushes, herbs, grasses, submerged, and emergent present.</p> | Good | |

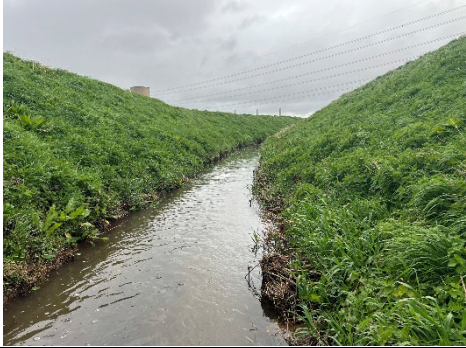
- A possible otter spraint (tarry stain) was observed under a bridge on the northern boundary of the Site on the Catchwater drain (ED12).
    - Additionally, an incidental observation of remnants of an otter spraint (multiple overlapping stains) was also recorded off-site, ca. 170 m upstream of the Site boundary, under a bridge on the Catchwater Drain (FD4).

| CatchED 12 | 25 | 3.2 | Slow | 45, soil | <p>Trees and bushes absent, herbs, grasses, submerged, and emergent present.</p> <p>2 m height strand line from bed level indicates potential signs of fluctuating water levels.</p> <p>Fish and swan mussels were recorded within the Catchwater (CatchED13, CatchED13, and CatchFD4) during September 2024 survey.</p> | Good | |

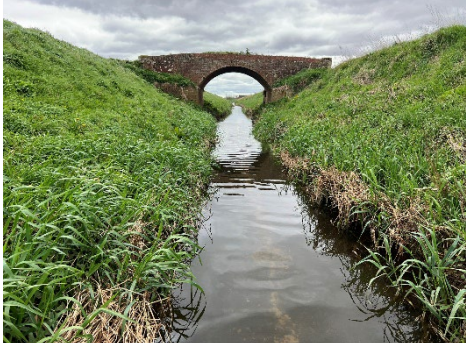
| CatchED 13 | 0.5-20 | 2.5 | Steady | 45, soil and silt | <p>Trees and bushes absent, herbs, grasses, submerged, and emergent present.</p> <p>Fish and swan mussels were recorded within the Catchwater (CatchED13, CatchED13, and CatchFD4) during September 2024 survey.</p> | Good | |

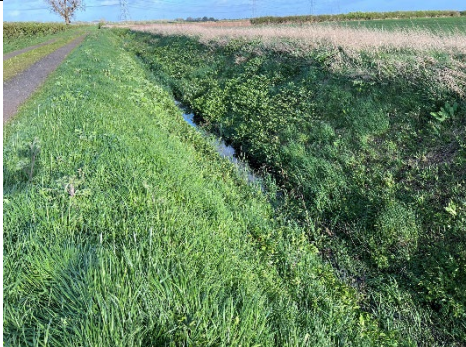
| FD1 | 0-25 | 0.8 | N/A-Slow | 45, soil | <p>Trees rare, bushes, herbs, grasses, submerged, and emergent present.</p> <p>Majority of length was dry by September 2024 except for the western extent.</p> | Poor | |

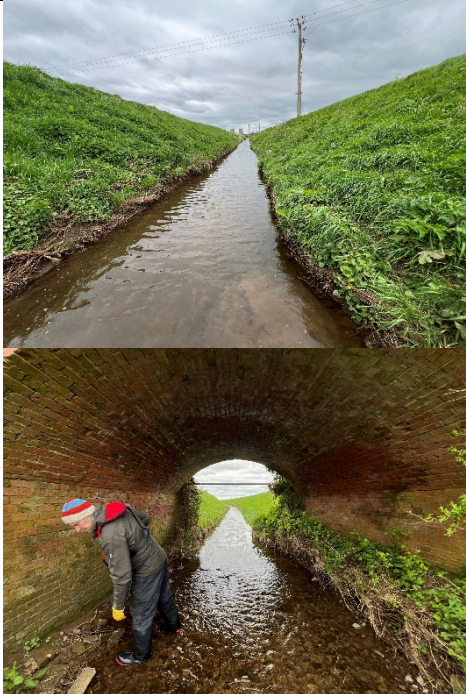
| CatchFD 4 | 0.5-20 | 2.5 | Steady | 45, soil | <p>Trees and bushes absent, herbs, grasses, submerged, and emergent present.</p> <p>Fish and swan mussels were recorded within the Catchwater (CatchED13, CatchED13, and CatchFD4) during September 2024 survey.</p> | Good | |

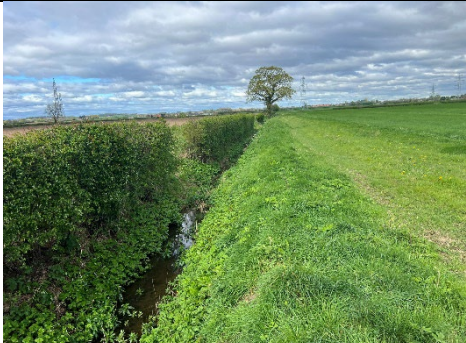
| FD5b | 20-40 | 1.1 | Still | 20-40, soil | <p>Trees, bushes, herbs, grasses, submerged, and emergent present.</p> <p>'Small vole' signs and rat burrows.<br/>Harvest mouse nest in bank.</p> | Good | |

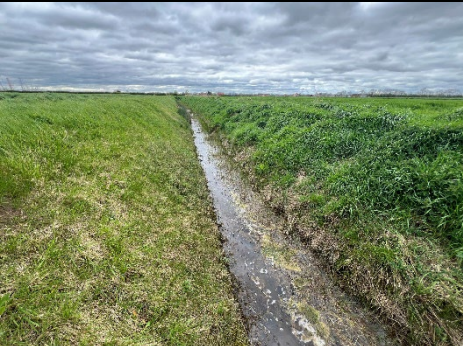
| FD5d | 40-50 | 1-1.5 | Still | 30-50, soil | Trees and bushes absent, herbs, grasses, submerged, and emergent present.<br><br>Indeterminant small mammal burrow present, no other field signs recorded. | Good | |

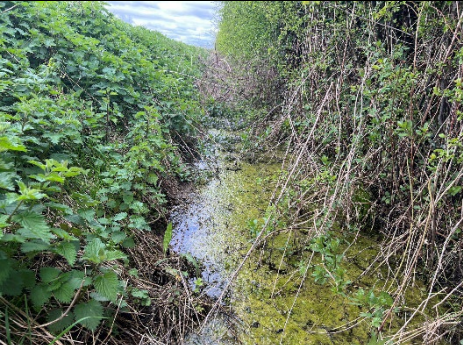
| FD6 | 0-25 | 1 | Still | 50, soil | Trees absent, bushes, herbs, grasses, submerged, and emergent present.<br><br>Dried by September 2024. | Negligible | |

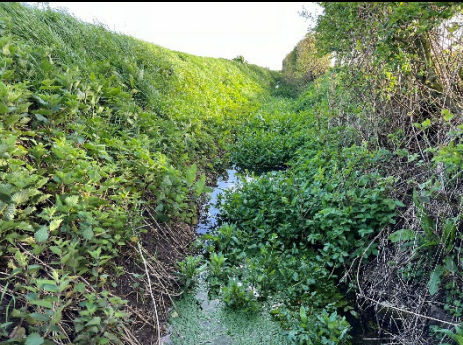
| FD7 | 0-40 | 1 | Slow | 50, soil | Trees absent, bushes, herbs, grasses, submerged, and emergent present.<br><br>Dried by September 2024. | Poor | |

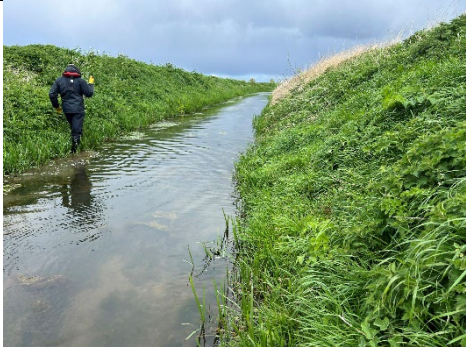
| HD5a | 50 | 4 | Sluggish | 45, soil and silt | Trees absent, bushes rare, herbs, grasses, and emergent present, submerged rare. | Optimal | |

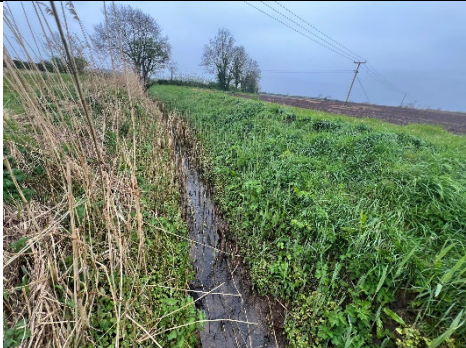
| Os'Beck | 10 | 0.7 | Rapid | 45-80, soil | Bushes dominant, trees, herbs, grasses, submerged, and emergent present. | Good | |
